MARINE INVESTIGATION REPORT

M04L0050

GROUNDING

CATHERINE-LEGARDEUR

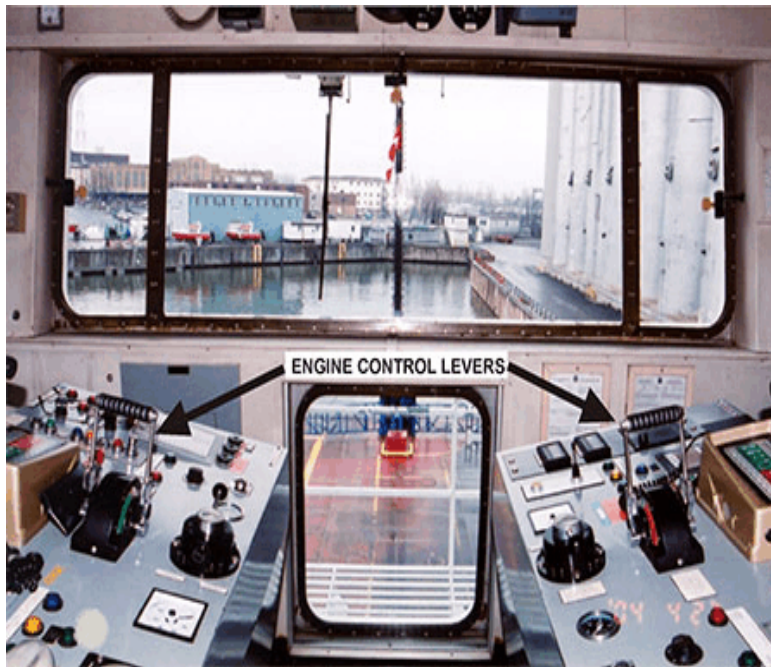
Photo 2. Bridge control consoles, looking either forward or aft

The *Catherine-Legardeur* is a double-ended ferry that carries passengers and vehicles across the St. Lawrence River between Sorel, Quebec, and Saint-Ignace-de-Loyola, Quebec. Both ends of the vessel are identical, each having a centreline rudder and propeller and a boarding ramp that provides vehicles with direct roll-on, roll-off convenience (see Photo 1). Dual engine and rudder controls are positioned at a central conning position in the wheelhouse, such that they can be readily activated by a single operator (see Photo 2).

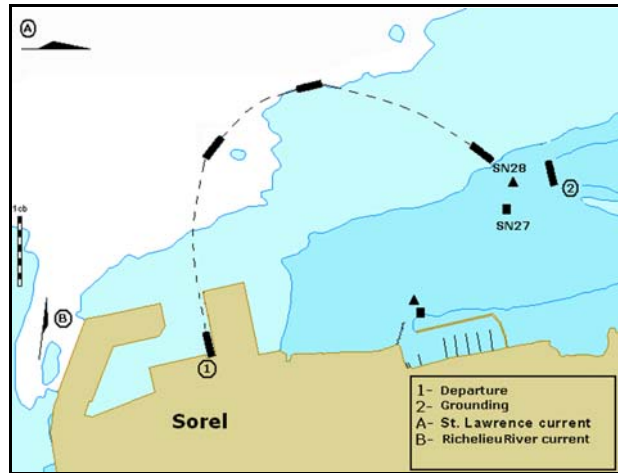
Figure 1. Approximate track of ferry to grounding

By 0535, the vessel was underway and once it cleared the Lanctôt basin and passed the jetties, it quickly fell off to starboard into the river current setting approximately 075° at two knots (see Figure 1). The master and mate both noticed that the gyrocompass repeater heading was rapidly turning to the east.

When the navigation personnel monitored the radars, both set on the 1.5 nautical mile scale, the echoes of the nearby landmass were seen to be quickly shifting, creating a blurred image from which the navigation personnel were unable to determine the vessel's position. Without visual cues or an understanding of the radar information because of the blurred image due to the swing, the master and mate used the GPS receiver's changing readout to gain an appreciation of the vessel's speed. As an attempt was made to bring the vessel to a stop with the help of this navigation instrument, the lookout reported seeing buoys ahead. The master manoeuvred to avoid the buoys and, shortly thereafter, at approximately 0545, the vessel grounded in position 46°03'08" N, 073°06'09" W, on a heading of 168° gyro (see Figure 1 and Appendix A).

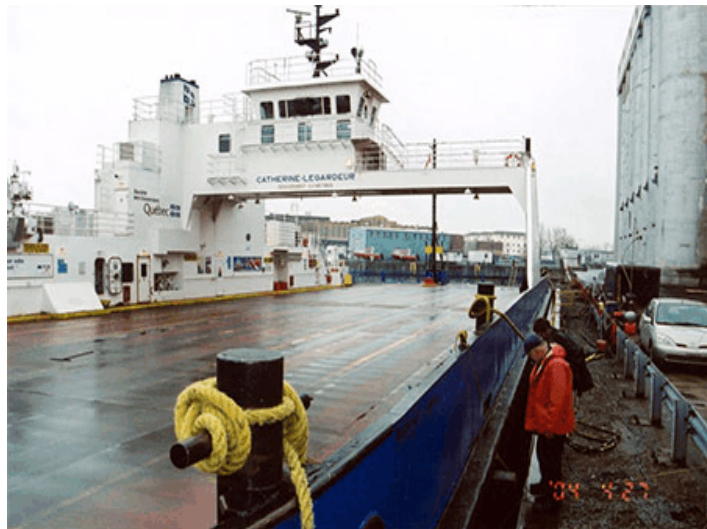
Photo 3. *Catherine-Legardeur* with cleared deck

At 0817, the fog had lifted and, with the assistance of the tug *Ocean Gulf*, the *Catherine-Legardeur* was refloated. The ferry then continued its crossing to Saint-Ignace-de-Loyola, disembarked all vehicles and passengers, and returned to Sorel, empty, to undergo inspection (see Photo 3). No apparent damage was found and the ferry resumed service later that day.
